# 'Signal' failures on Mostyn at the Palace

Welcome to the continuing story of Mostyn and how a group of friends have sought to re-create a slice of BR corporate blue heaven on the North Wales Coast main line in the Summer of 1977. You might think that, after eight years on the exhibition circuit and many hundreds of hours of test running, there were no more surprises but you would be wrong. Our recent appearance at Alexandra Palace exhibition opened our eyes to a whole new world of potential problems.

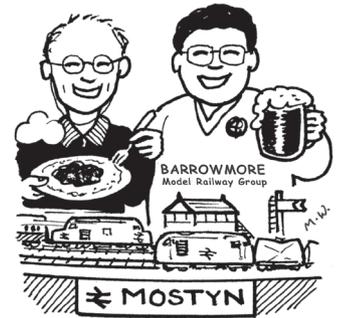
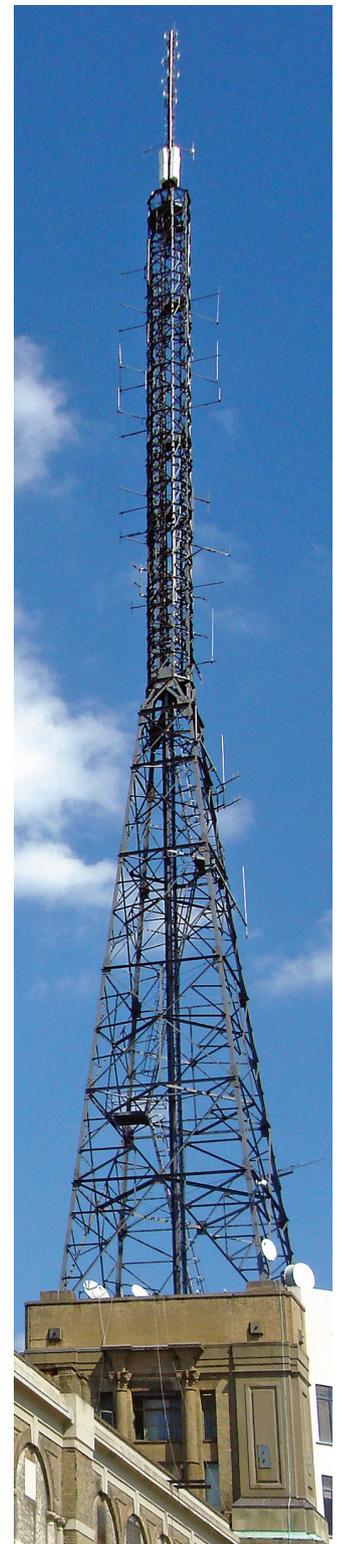
The famous 67-metre tall TV mast at Alexandra Palace. Built in 1936, it may or may not be compatible with early Lenz decoders! Panhard

"I'd suggest that the various transmitters at Alexandra Palace (a combination of UHF Television and VHF Radio) along with the particular configuration/orientation of the wiring of the Down Main might have combined to interfere with the operation of the 1025E decoders. The cure was the enhanced ability of recent decoders to recover the DCC track signal in difficult conditions (usually caused by dirt) or better design in general. In the words of one of my fellow modellers. "So you are blaming the big metal spiky thing on the roof". There's something new to learn every day... ■
